Technical Bulletin TB - 0109

To : All Trailer Mounted 120 Machine Owners
From: Malcolm North
Date: 26/06/2014
Our Ref TB- 0109
Re: Cracked Cylinder
Affected: All Trailer Mounted 120's Produced since 1985 to Present

Mandatory Safety Check – 120M/H/T

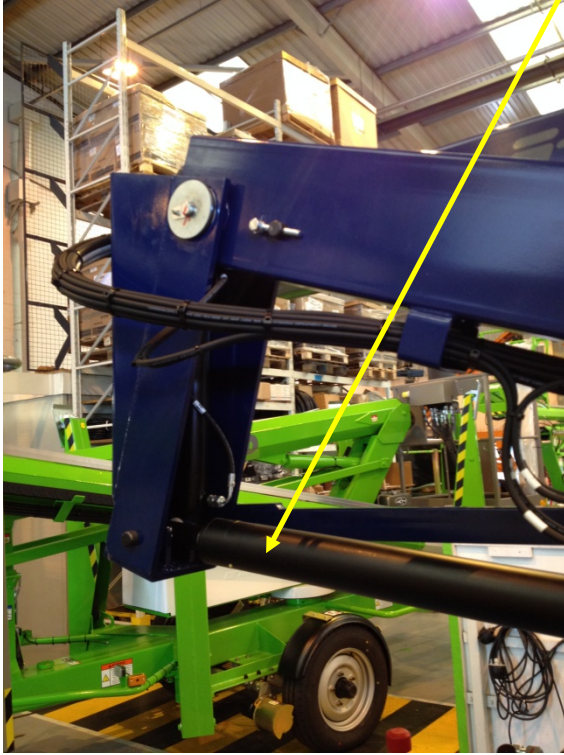
Fig 1.

It has been identified that over time lift cylinder 2 (fig.1) may suffer from material fatigue around the shaft pivot point (fig.3). Our findings point to a number of potential factors that may contribute to this fatigue such as vibration through road transport, lack of boom travel clamp and impact to the machine structure.

Cylinder Location:

In light of this, it is recommended that in addition to the daily/weekly/monthly inspections an additional visual inspection of the cylinder must take place immediately. The cylinder can be visually inspected at rest on the upper surface, then again for the bottom surface by operating the cylinder in question to full height. During the inspection, if the paint surface has not cracked then no further action is required. Should the paint show signs of cracking then removal of the paint would be required for a closer inspection of the chrome shaft.
