*Promoting the safe and effective
use of powered access worldwide*

IPAF GLOBAL SAFETY REPORT 2022

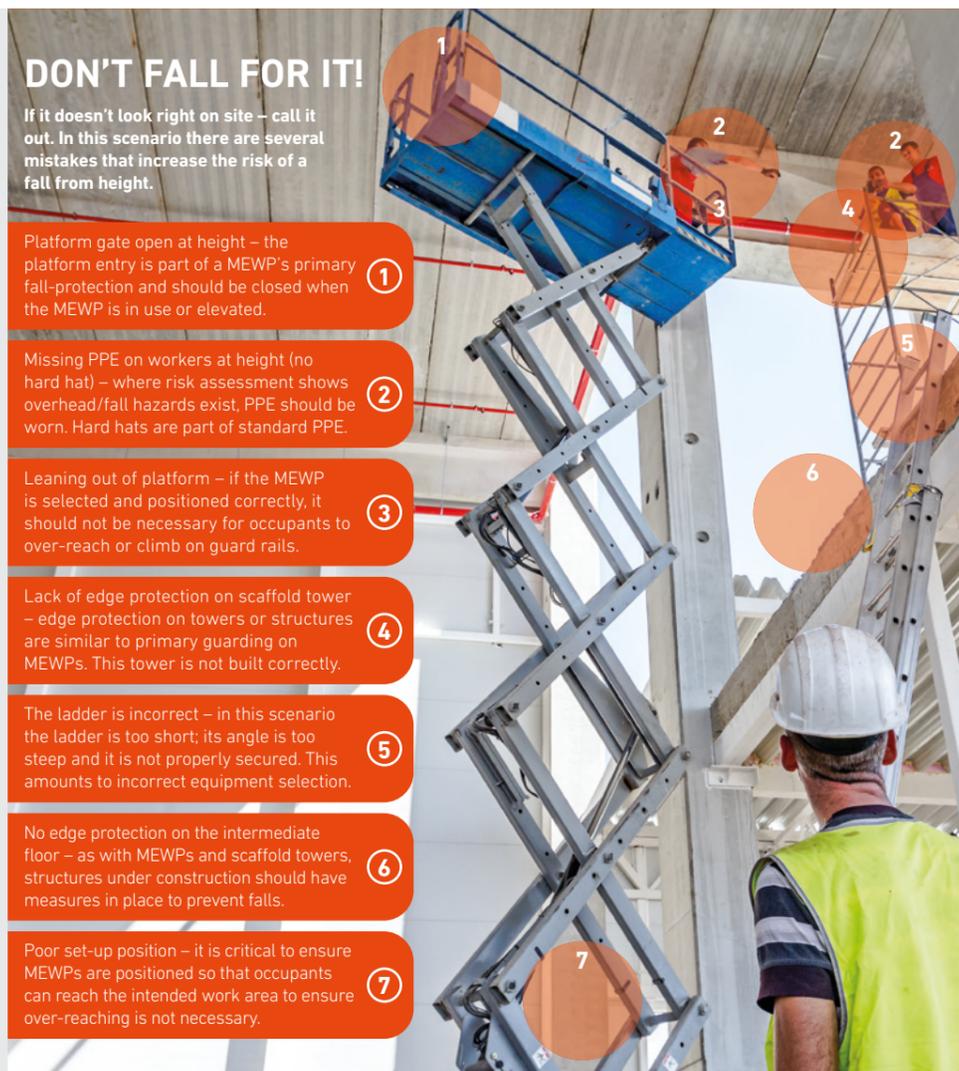
DON'T FALL FOR IT!

If it doesn't look right on site – call it out. In this scenario there are several mistakes that increase the risk of a fall from height.

Missing PPE on workers at height (no hard hat) – where risk assessment shows overhead/fall hazards exist, PPE should be worn. Hard hats are part of standard PPE. ②
